Hyland Road Substation Site,
Holroyd NSW
**ABORIGINAL ARCHAEOLOGICAL
& CULTURAL HERITAGE ASSESSMENT**

FINAL REPORT

For
Sinclair Knight Merz
On behalf of
TransGrid

December 2009
Job No: N9002

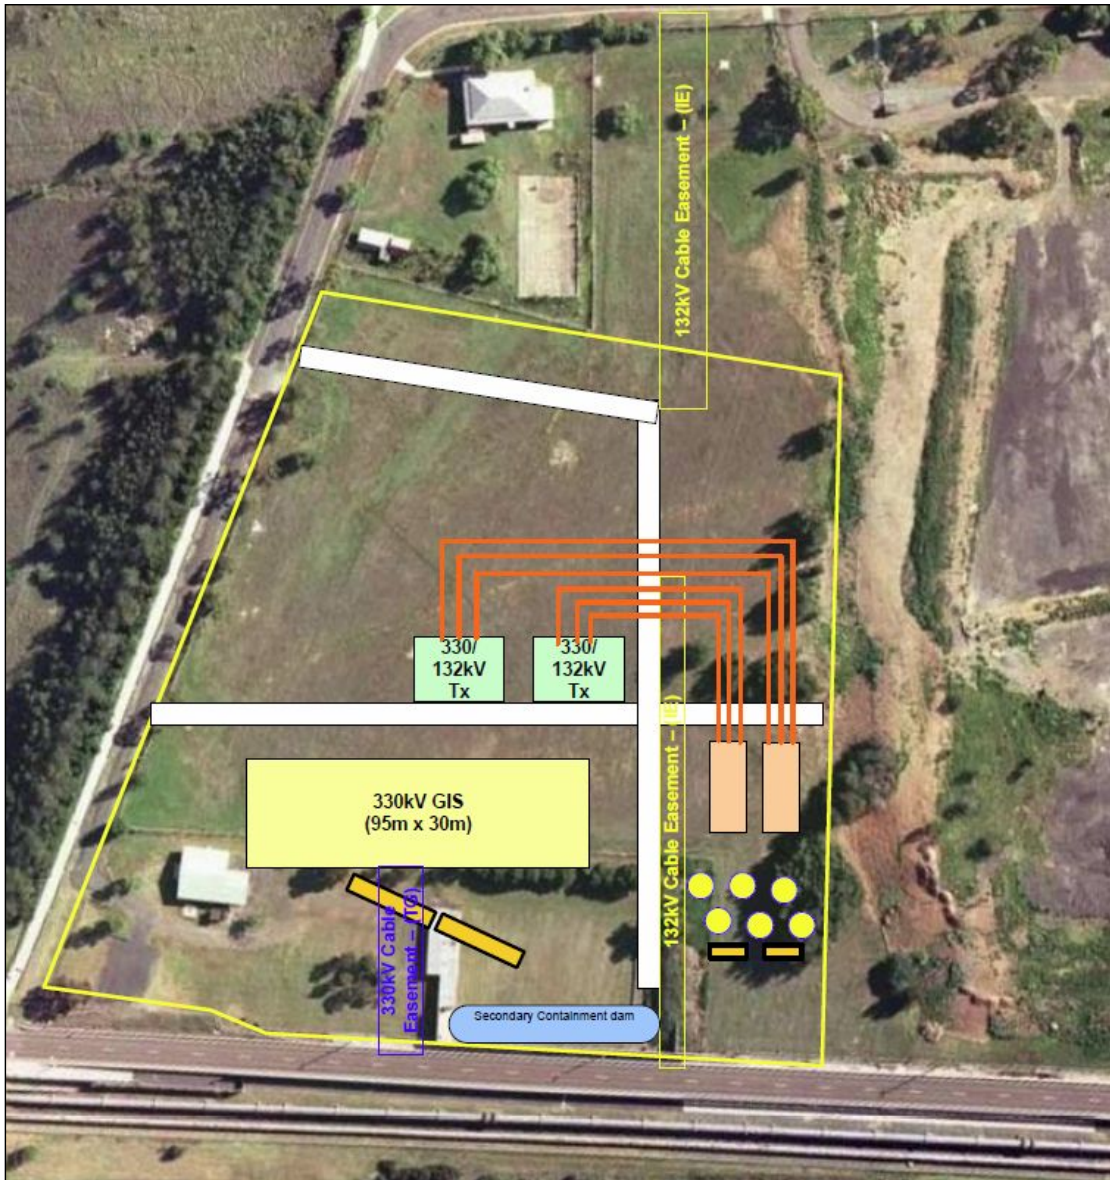
Figure 1.3 Layout of features within substation site. Image © TransGrid 2009.

Impacts within the 4 ha parcel of land for the substation, as shown in Figure 1.3, will include:
