From: Lee Kingma [REDACTED]
Sent: Friday, 11 June 2021 8:50 AM
To: RIT-T Consultations
Cc: Bronwyn Rosser; James Tydd
Subject: RIT - Managing safety and environmental risks on Line 18 (Kangaroo Valley – Dapto)

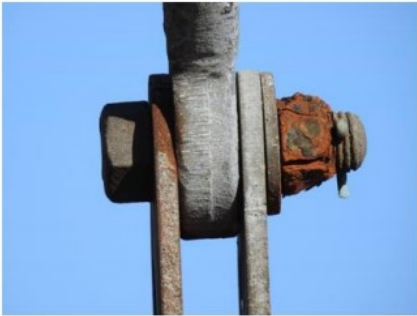
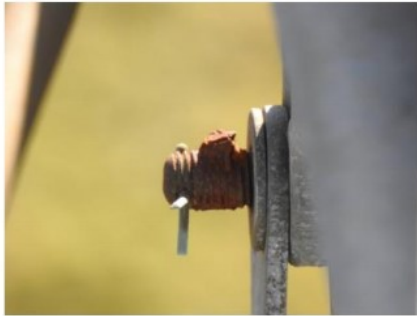
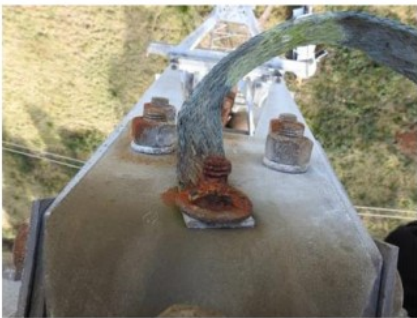
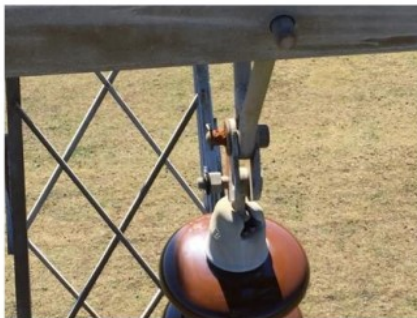
Figure 2-3 Corroded conductor and earthwire fittings

Lastly, the images in the report show examples of fastener corrosion as justification for the project. Figure 2-3 in particular shows heavily corroded nuts but the bolts appear to still have their coating intact. An alternative approach for this project and in general would be replacing the nuts, or both the nuts and bolts identified as partly corroded during off-line maintenance inspections, before the issue becomes a community safety issue.
